Manhole Inspection Summary

Manhole # S21MM_036MH

Location Address: **2133 FULTON AVE**

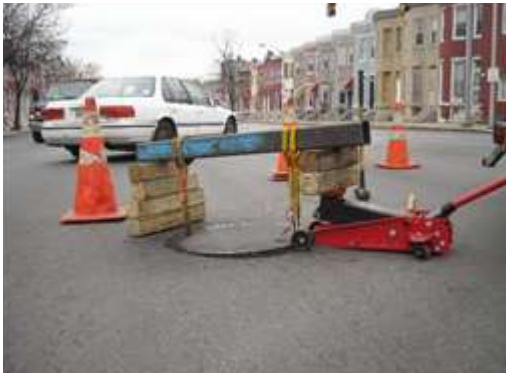
Location View

OPENED LID USING JACK AND BOLT METHOD - LOOKING SOUTHBOUND ON FULTON ST

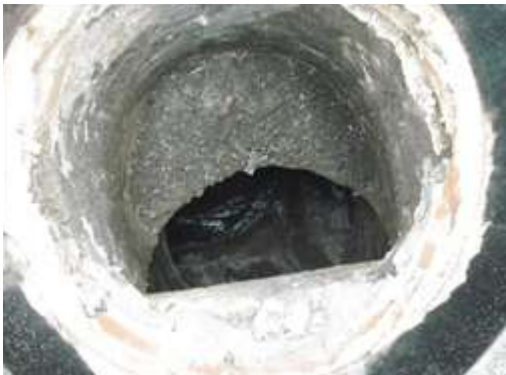
Top View

TOP VIEW FROM CHIMNEY

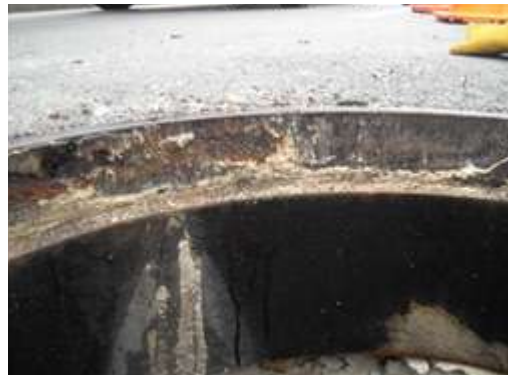
Subject To Ponding: **Sheeting**

EVIDENCE OF INFILTRATION DUE TO SHEETING

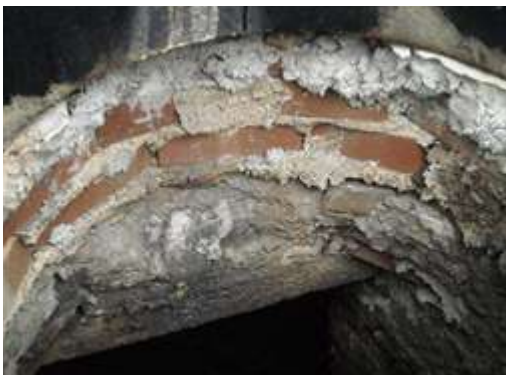
Defect 3

Condition: ☐ Sound ☐ Cracked ☐ Root Intrusion ☒ Loose Brick ☒ Deteriorated

CHIMNEY ADJUSTMENT

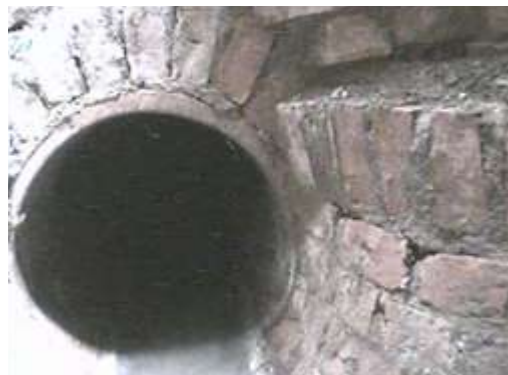
Defect 2

Condition: ☐ Sound ☐ Cracked ☐ Root Intrusion ☒ Deteriorated ☐ Leaks ☐ Debris

DEGREDDATION OF CHANNEL ON LEFT

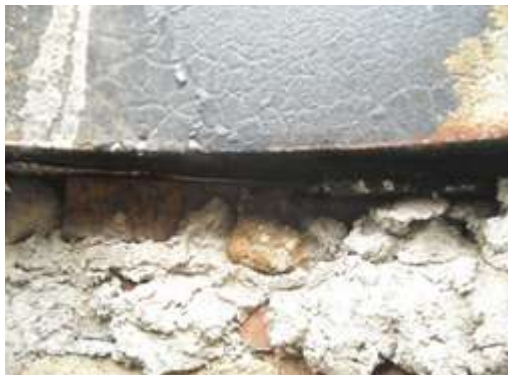
Defect 1

3" GAP BELOW FRAME

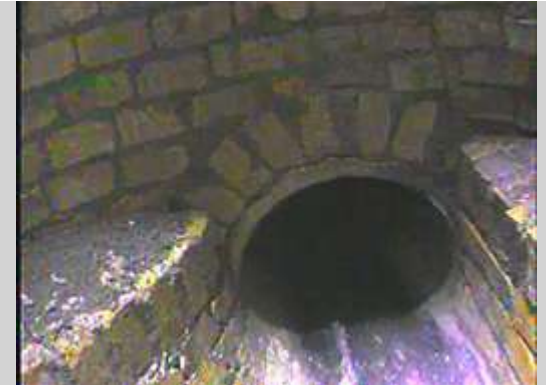
12 O'Clock Outflow

Pipe Height: **14.4** (in.) Rod and Bar (Angled)
Pipe Material: **Clay** ☐ Pipe Lined
Invert Depth: **11.54** (ft.) Flow Characteristics: **Fast**
Deposits: ☒ None ☐ Mud ☐ Sludge ☐ Debris ☐ Grease
Silt Depth: (in.) Deposits Extent:
Infiltration: **None** Pipe Seal Cond: **Sound**

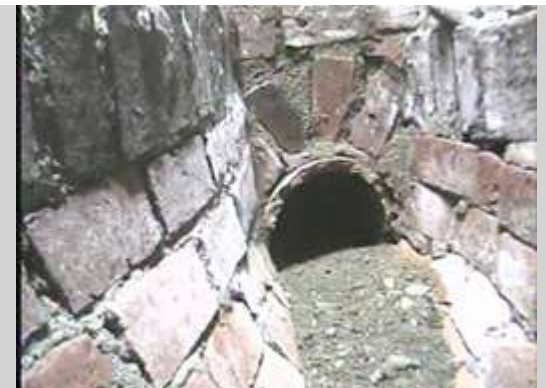
4 O'Clock Inflow

Pipe Height: **8.4** (in.) Rod and Bar (Angled)
Pipe Material: **Clay** ☐ Pipe Lined
Invert Depth: **11.48** (ft.) Flow Characteristics: **None**
Deposits: ☒ None ☐ Mud ☐ Sludge ☐ Debris ☐ Grease
Silt Depth: (in.) Deposits Extent:
Infiltration: **None** Pipe Seal Cond: **Sound**

Connects To: **Stub connection / abandoned**

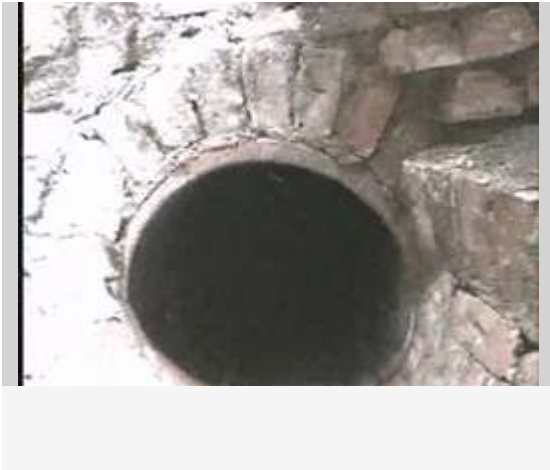
9 O'Clock Inflow

Infiltration: **None**

Pipe Seal Cond: **Sound**
